***Crooked Lake
Aquatic Vegetation Management
Plan 2007-2011***

February 27, 2007

**Prepared by:
Aquatic Control, Inc.
PO Box 100
Seymour, Indiana 47274**

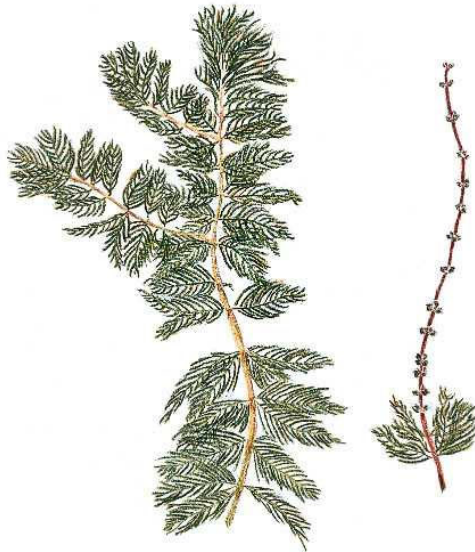
Figure 3. Illustration of Eurasian watermilfoil (Illustration provided by Applied Biochemist).

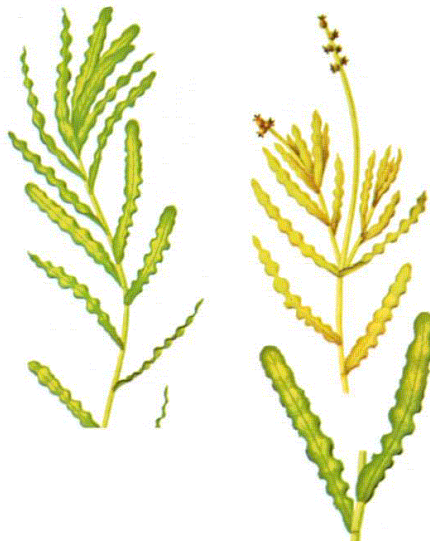
Figure 4. Illustration of curlyleaf pondweed (Illustration provided by Applied Biochemist).

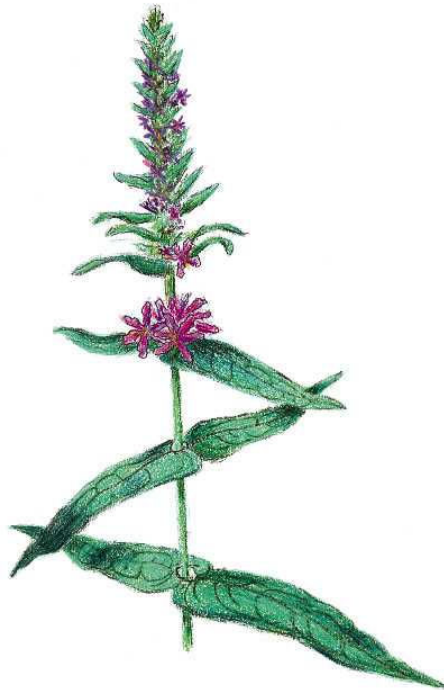
Figure 5. Illustration of Purple Loosestrife (Illustration provided by Applied Biochemist).

Purple loosestrife is an exotic invasive species of emergent vegetation that has invaded many wetlands and lake margins throughout Indiana (Figure 5). This species was introduced from Eurasia and became established in the estuaries of northeastern North America by the early 1800's. The impact of purple loosestrife on native vegetation has been disastrous, with more than 50% of the biomass of some wetland communities displaced. Impacts on wildlife have not been well studied, but indicate serious reduction in waterfowl and aquatic furbearer productivity (Thompson et. al., 1987).

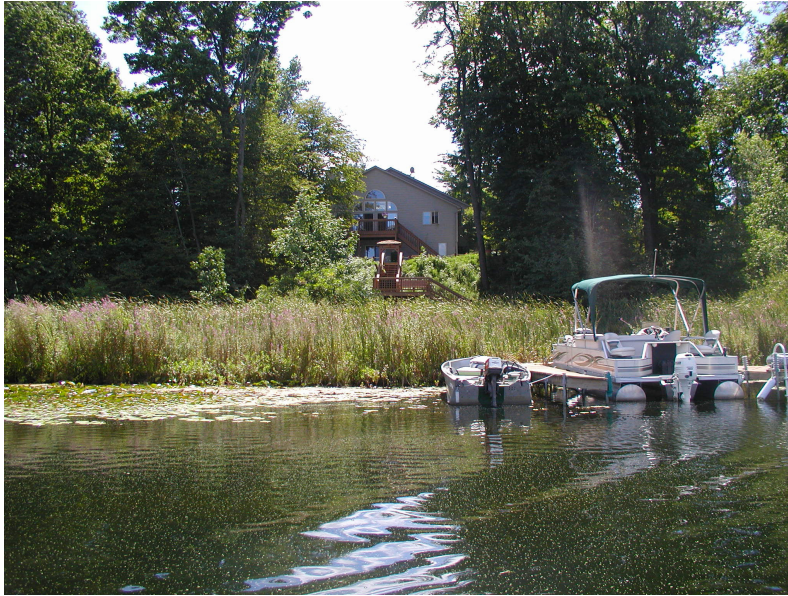
Figure 16. Crooked Lake, emergent plant community along developed shoreline, June, 2006.

The third basin has a dense and diverse shallow wetland plant community, especially along the western side of the third basin. This community serves several beneficial purposes to Crooked Lake that includes reducing erosion, providing fish and wildlife food and habitat, and filtering excessive nutrients. This plant community should be protected from development. Several large homes have lake access and are located within this wetland area. The homeowners have developed far enough back from the wetland area that the impact from this development is less severe. The homeowner's have docks that run through the emergent community out to open water, thus the homeowner's do not have to remove vegetation in order to have lake access. The homeowner's have also allowed emergent vegetation to flourish along their lake property (Figure 16). This should be an example to other homeowner's as a more effective land management practice and should be encouraged in future development and for older residences.

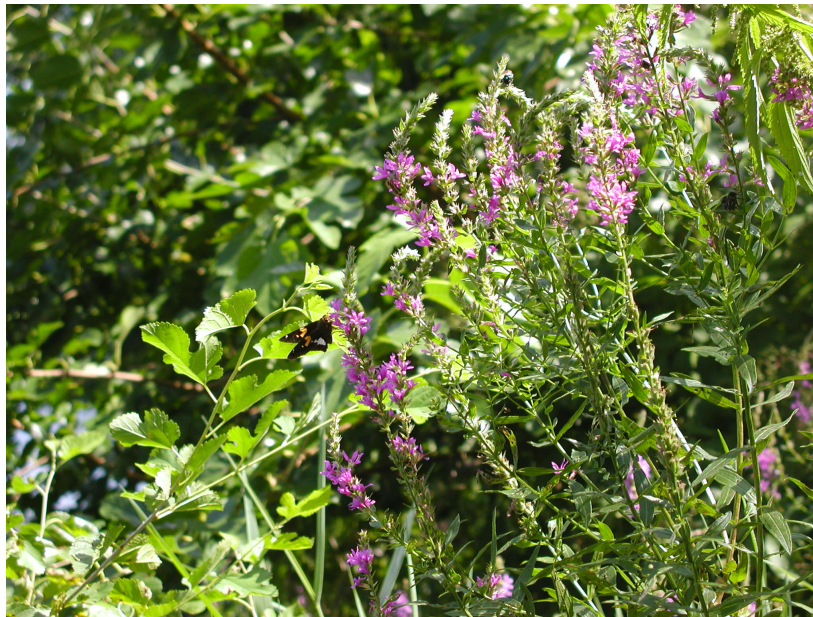
Figure 18. Purple Loosestrife in Crooked Lake, June, 2006.

There are chemical controls that are very effective on this species, but due to the extent of the infestation it is not economically feasible to hire an outside contractor to spray the entire shoreline of the Crooked Lake. It will be important to individual homeowners to dig up and remove the entire plant. An illustration of this species can be seen in Figure 5 and a picture of this plant taken at Crooked Lake is below in Figure 18.

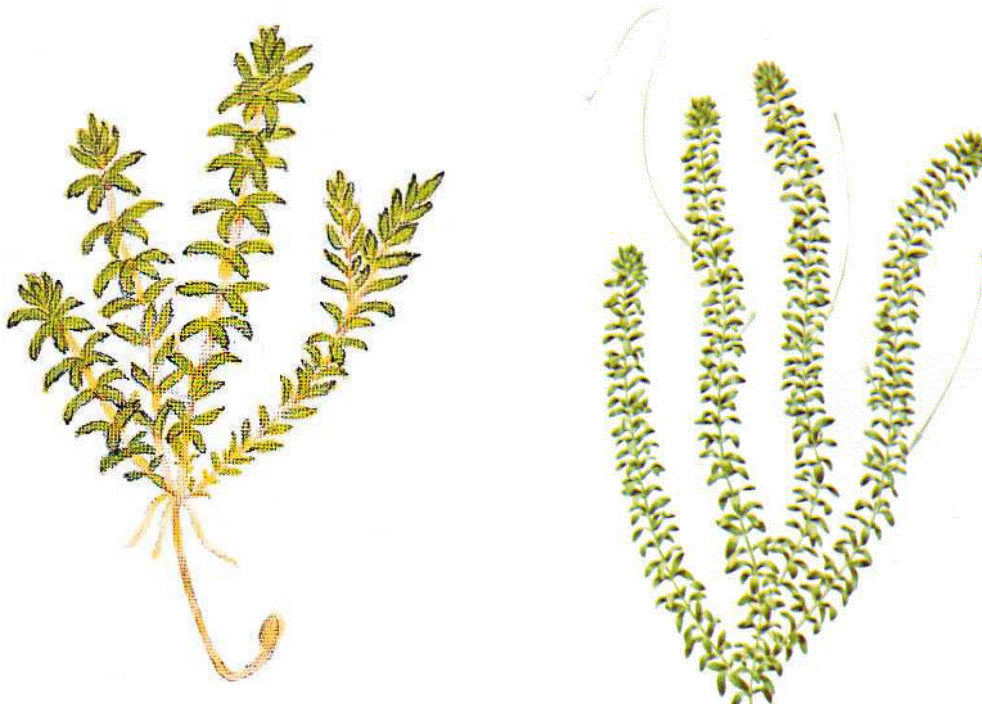
Figure 19. Illustration of hydrilla on the left compared to native elodea on the right. Hydrilla typically contains five toothed leaves per whorl while native elodea typically has three leaves per whorl and the teeth are not visible on the leaves (Illustrations provided by Applied Biochemist).

Hydrilla, an extremely aggressive submersed aquatic plant species, has been recently discovered in Lake Manitou, which is located in north central, Indiana. Currently, it is believed that this plant is isolated in the Lake Manitou area, but much like Eurasian watermilfoil, this species has the ability to reproduce by fragmentation. This allows it to be spread easily from lake to lake. It is very important that lake users understand the importance of thoroughly cleaning off their boats when entering and exiting Flint Lake. Posting signs at the ramp will help reinforce this point. Warnings about this plant should also be sent to members of the Association. The best way to distinguish hydrilla from native elodea is that hydrilla typically has five leaves along each whorl along with visible serrated edges along the leaf margin (Figure 14). More information about controlling the spread of hydrilla can be found at www.protectyourwaters.net. An illustration of hydrilla and native elodea follows in Figure 19.
